Case Study: RIVERFRONT PARK, NASHVILLE, TENNESSEE

Overview/History

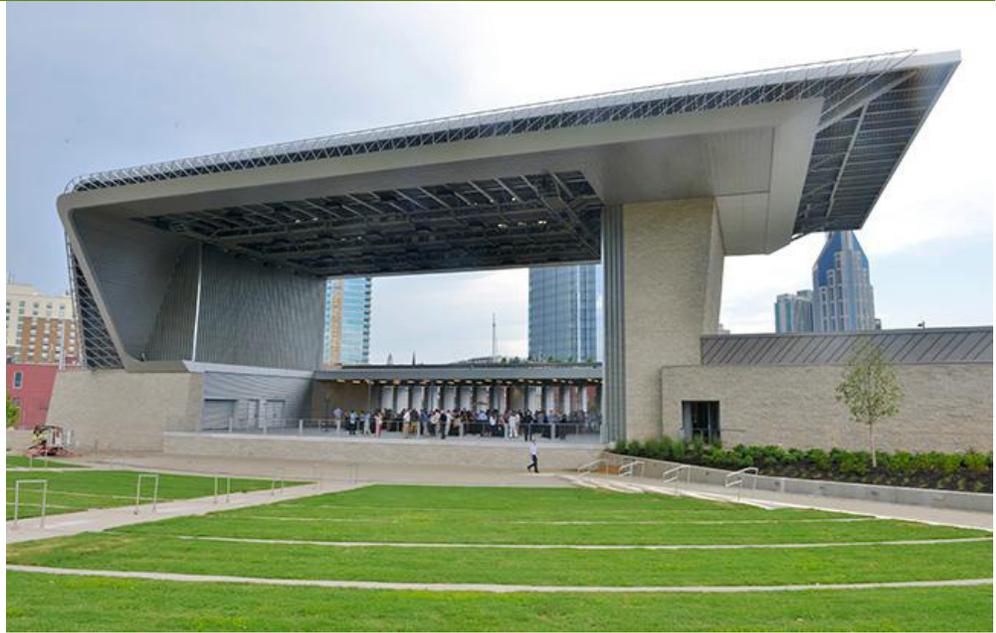
Protection from 500-year flood events is provided by an integrated flood wall that was built two feet above the 2010 flood levels. The wall doubles as seating and is not instantly recognizable as a flood protection feature, in keeping with the "park first" mandate for all features of the development.
