Faro, Portugal

Dune Rehabilitation in Praia do Faro

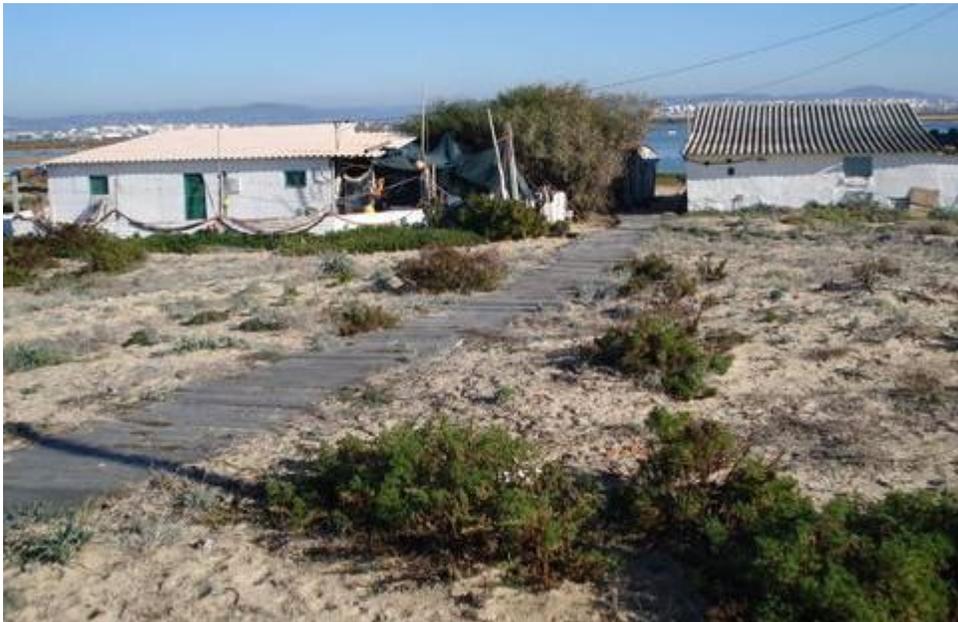
Praia do Faro before the implementation of the elevated wooden pathway. Source:

Overview/History: The dunes protecting Praia do Faro were degraded by housing and tourism activities that led to

the establishment of unauthorized pathways and use of the dune system. This use has resulted in degradation of the dune system and loss of various ecological functions, including deteriorated coastal protection. Due to the location of the dunes within the Ria Formosa Natural Park, their long-term preservation and immediate rehabilitation to enhance ecological functions such as flood reduction was a management imperative for the Natural Park Service. Thus, the rehabilitation of the dunes was proposed as a nature-based approach to manage flood risk.

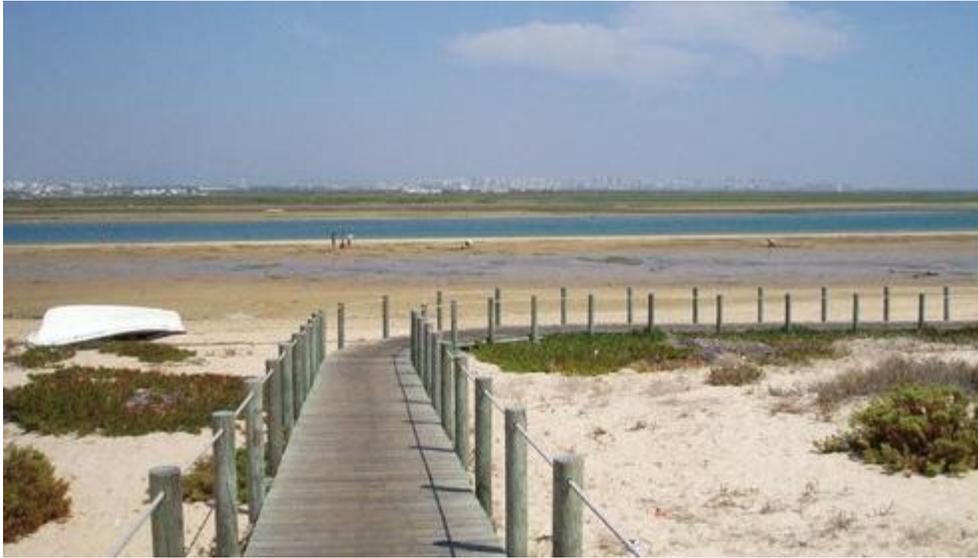
Praia do Faro after the implementation of the elevated wooden pathway. Source: <https://www.coastal-management.eu/measure/example-cost-effectiveness-analysis-wooden-path-over-dune-praia-de-faro-pt>

Solution: The main goal of the project was to restore the dune system at Praia de Faro in Portugal. In 2000/2001, an elevated wooden pathway with dune fencing was constructed both along-shore and cross-shore within the Park's dune system project area. The total length of the pathway was \approx 1.5 km. Part of associated dune fencing was built as a reticulate throughout 670 m of shoreline, which enhanced the entrapment of sand, for the expansion of the dunes system.

After more than 15 years of focused foot traffic by visitors on the elevated wooden pathways and associated dune fencing, the dune system grew 10 m in width and around 1.3 m in height. The dune

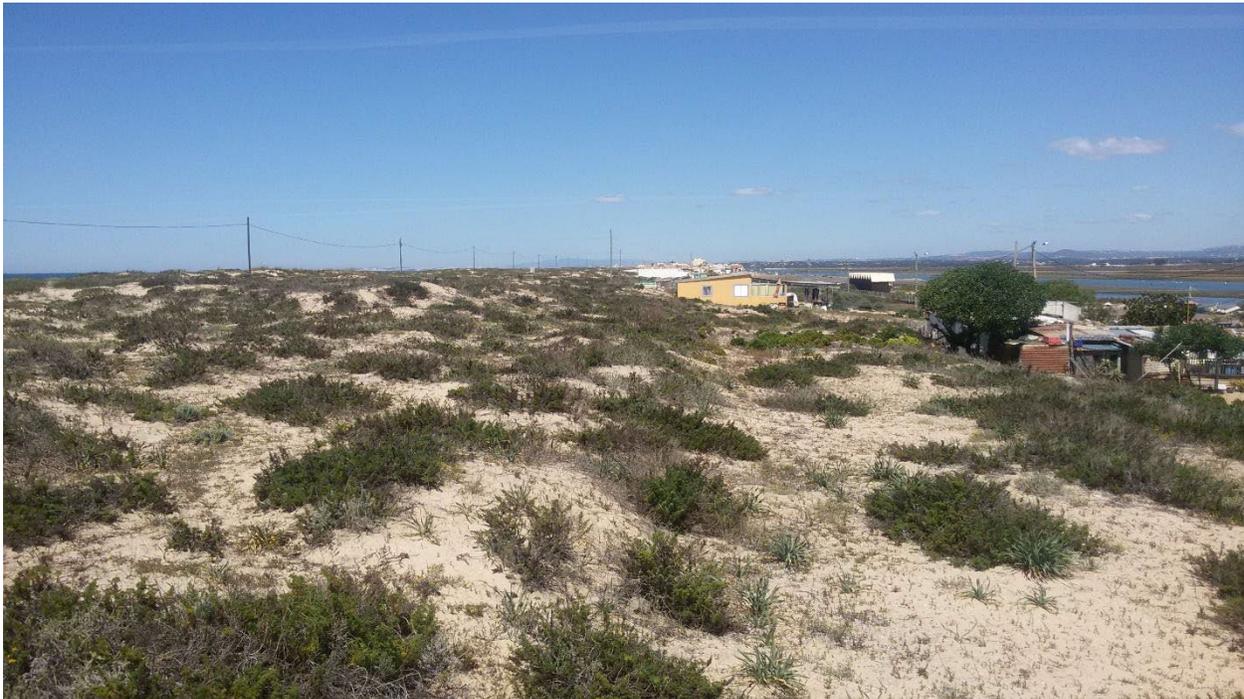
Praia do Faro after the implementation of the elevated wooden pathway. Source: <https://www.coastal-management.eu/measure/example-dune-rehabilitation-praia-de-faro-pt>

After more than 15 years, the dunes grew 10 m in width and around 1.3 m in height.
